Manhole Inspection Summary

Manhole # S69C1_006MH

Insp Date: **12/1/08 2:31 PM**

Location Address: **Cleveland Ave.**

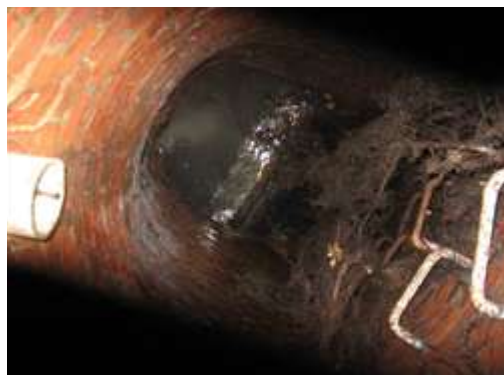
Top View

Comments **HEAVY ROOT INTRUSION LIKE A TREE GROWING IN THE MANHOLE. PIECES OF THE WALL FALLING AND FLAKING OFF DUE TO DETERIORATION.**

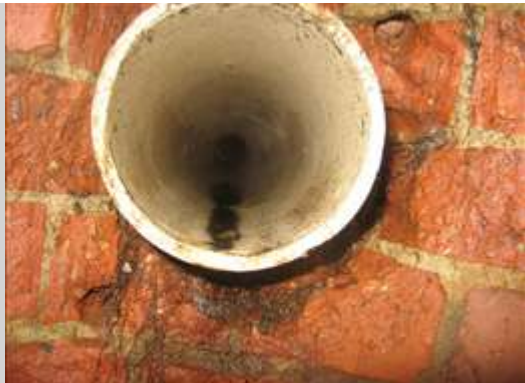
9 O'Clock Inflow

Pipe In @ 9 O'Clock

Pipe Height: **6** (in.) Rod and Bar (Angled)

Pipe Material: **PVC** ☐ Pipe Lined

Infiltration: **None**
